TWR-17371

Space Shuttle Development Motor No. 9 (DM-9) Final Test Report

September 1990

Thiokol CORPORATION
SPACE OPERATIONS

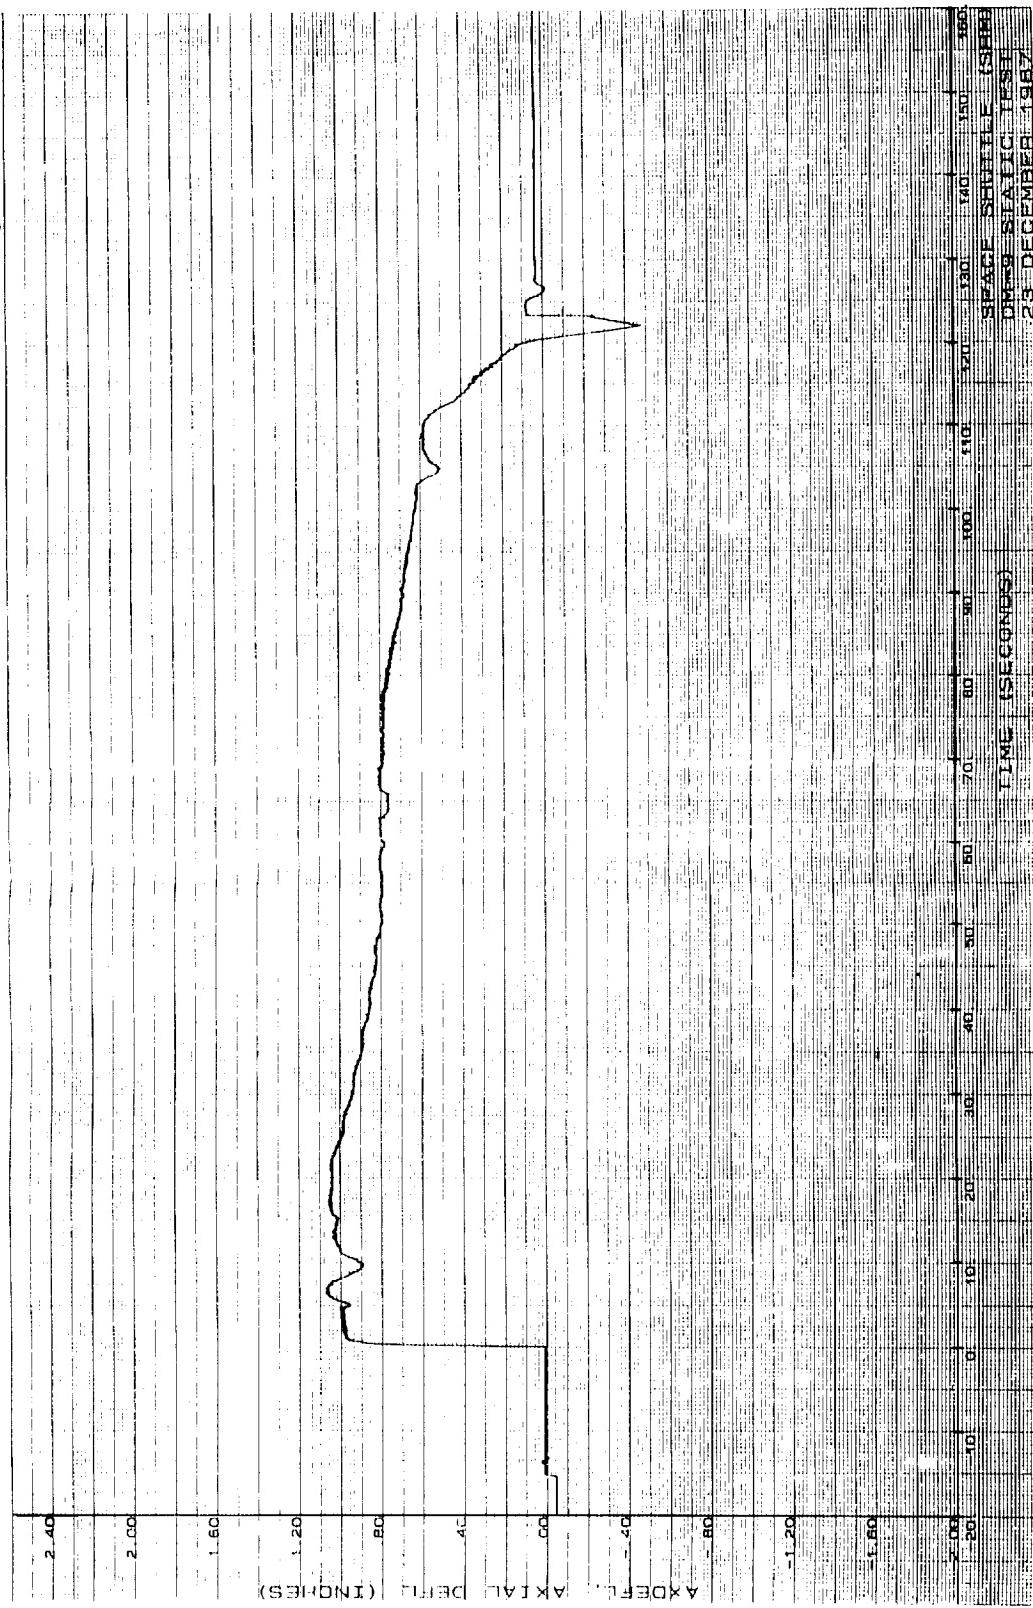
Figure 7.5-108. DM-9 Axial Deflection

Axial deflection as a function of time is shown in Figure 7.5-108. Figure 7.5-108 shows that at the end of burn time, when the nozzle stagnation pressure was approximately ambient, there was a maximum axial deflection of 0.48 in. (forward direction). The most probable cause of the tensile deflection was pressurized gas in the cavity between the flex bearing and boot due to plugged vent holes in the cowl. It was determined that a pressure of approximately 109 psi would cause the deflection seen. Similar occurrences were experienced on previous static tests including QM-2 (-0.66 in.), QM-3 (-0.60 in.), QM-4 (-0.91 in.), DM-6 (-1.08 in.), DM-7 (-0.75 in.), DM-8 (-0.93 in.), and ETM-1A (-0.60 in.).

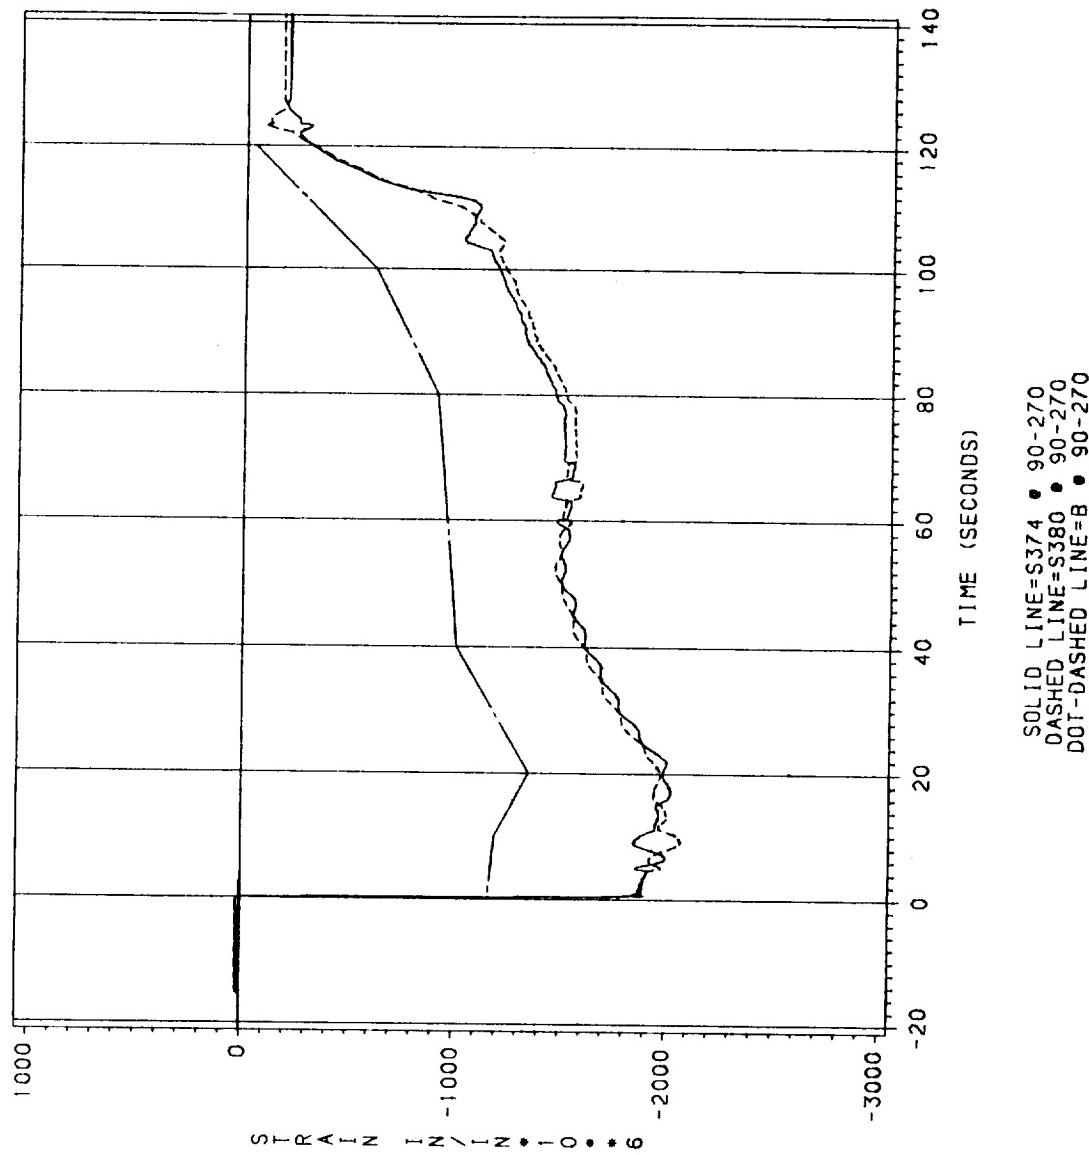
Figure 7.5-154. DM-9 Alt End Ring (hoop strain), Location 22

In general, predicted strains correlated with test data, and nozzle strains were small. Predicted hoop strains at locations 7 (aft end of the nose inlet housing) and 10 (throat joint region of the nose inlet housing), and meridional strains at locations 7 and 8 (the joint region at the nose inlet housing/forward end ring joint) need to be studied further. These gages are in regions of high-strain gradients where measurements are highly dependent on the accuracy of the gage placement. Predicted meridional strains at location 4 (forward end of the aft end ring) do not correlate with test results. However, the strains at this location are very low (less than 175 in./in.). No valid data was obtained at location 22 during the static firing due to faulty gages.

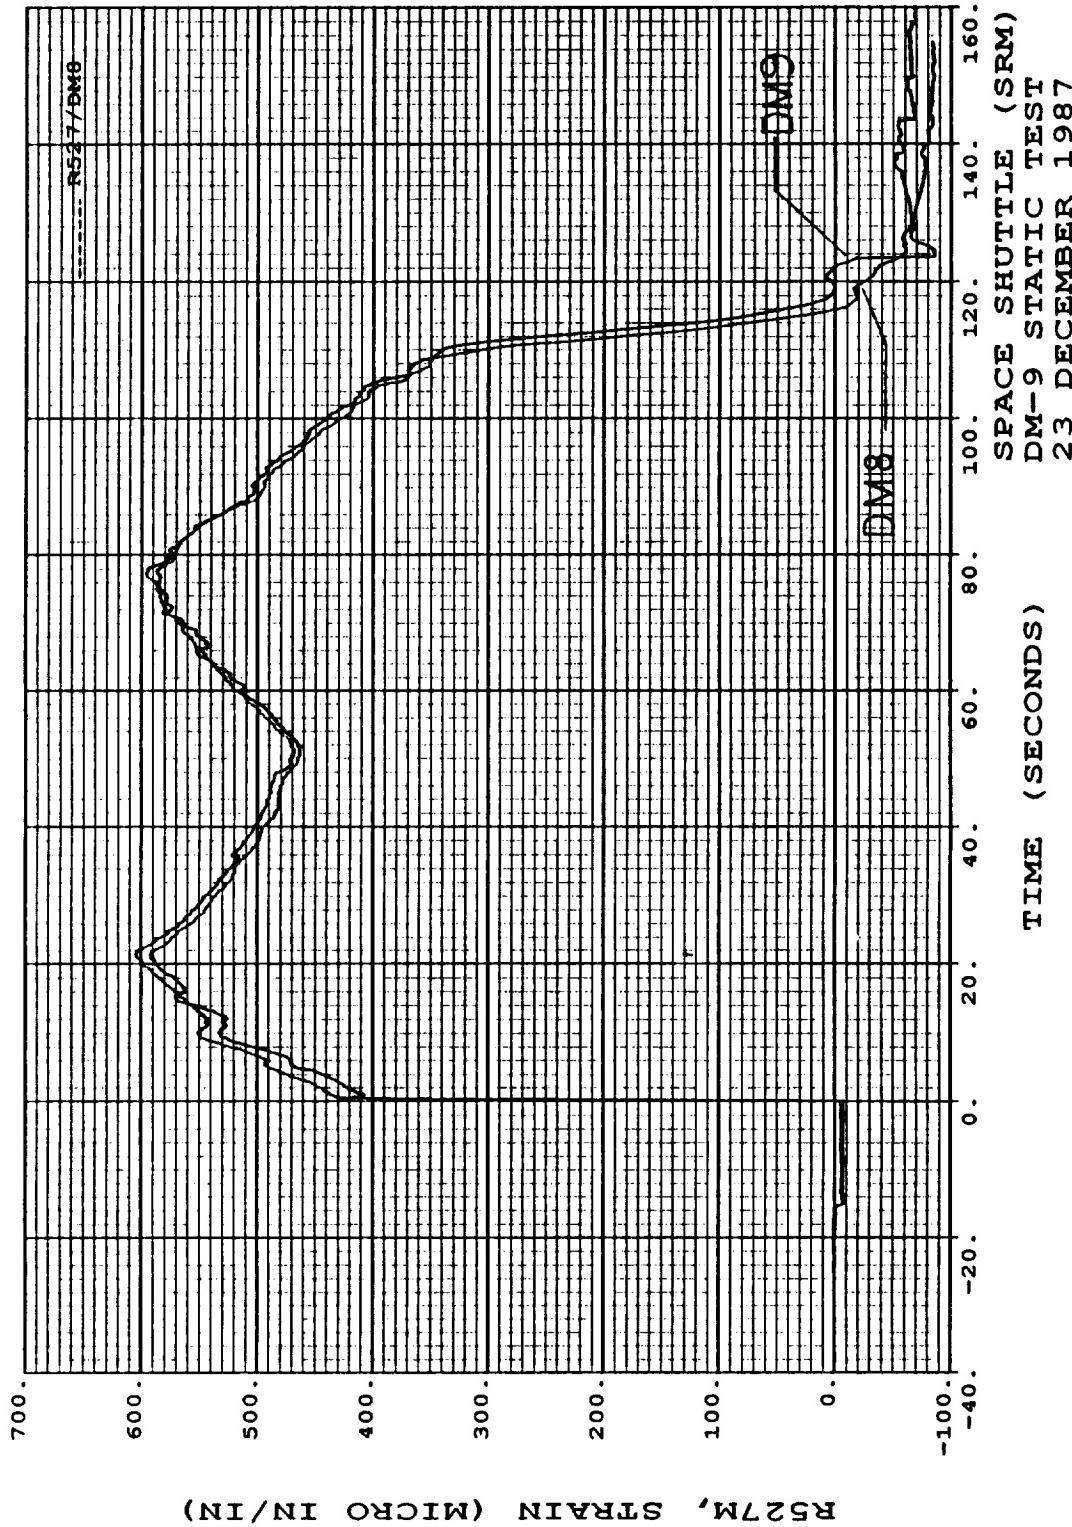
Figure 7.5-155. DM-9 and DM-8 Fixed Housing (meridional strains), 0 deg at Location 2

To determine the time at which the involute OBR failed, meridional strain gage data on the fixed housing was compared with test data at the same locations on the DM-8 motor. Figures 7.5-155 to 7.5-158 show the meridional strains of DM-8 and DM-9 motors at locations 2 and 3 for various azimuth angles. There are speculations that the ring was initially damaged during the +7 deg yaw vector event at about 112 sec. At about 123.5 sec, during the 6.3-deg TVC event, discontinuities in the strain data on the DM-9 motor indicated that the OBR apparently failed at this time. These discontinuities are evident in most DM-9 nozzle strain plots at the 123.5-sec timeframe. It was also noted that the vent holes in the cowl were partially plugged allowing a pressure of about 100 psi to build up in the flex boot cavity at tailoff. This pressure load combined with the vector event at about 123.5 sec could have caused the final damage to the OBR.

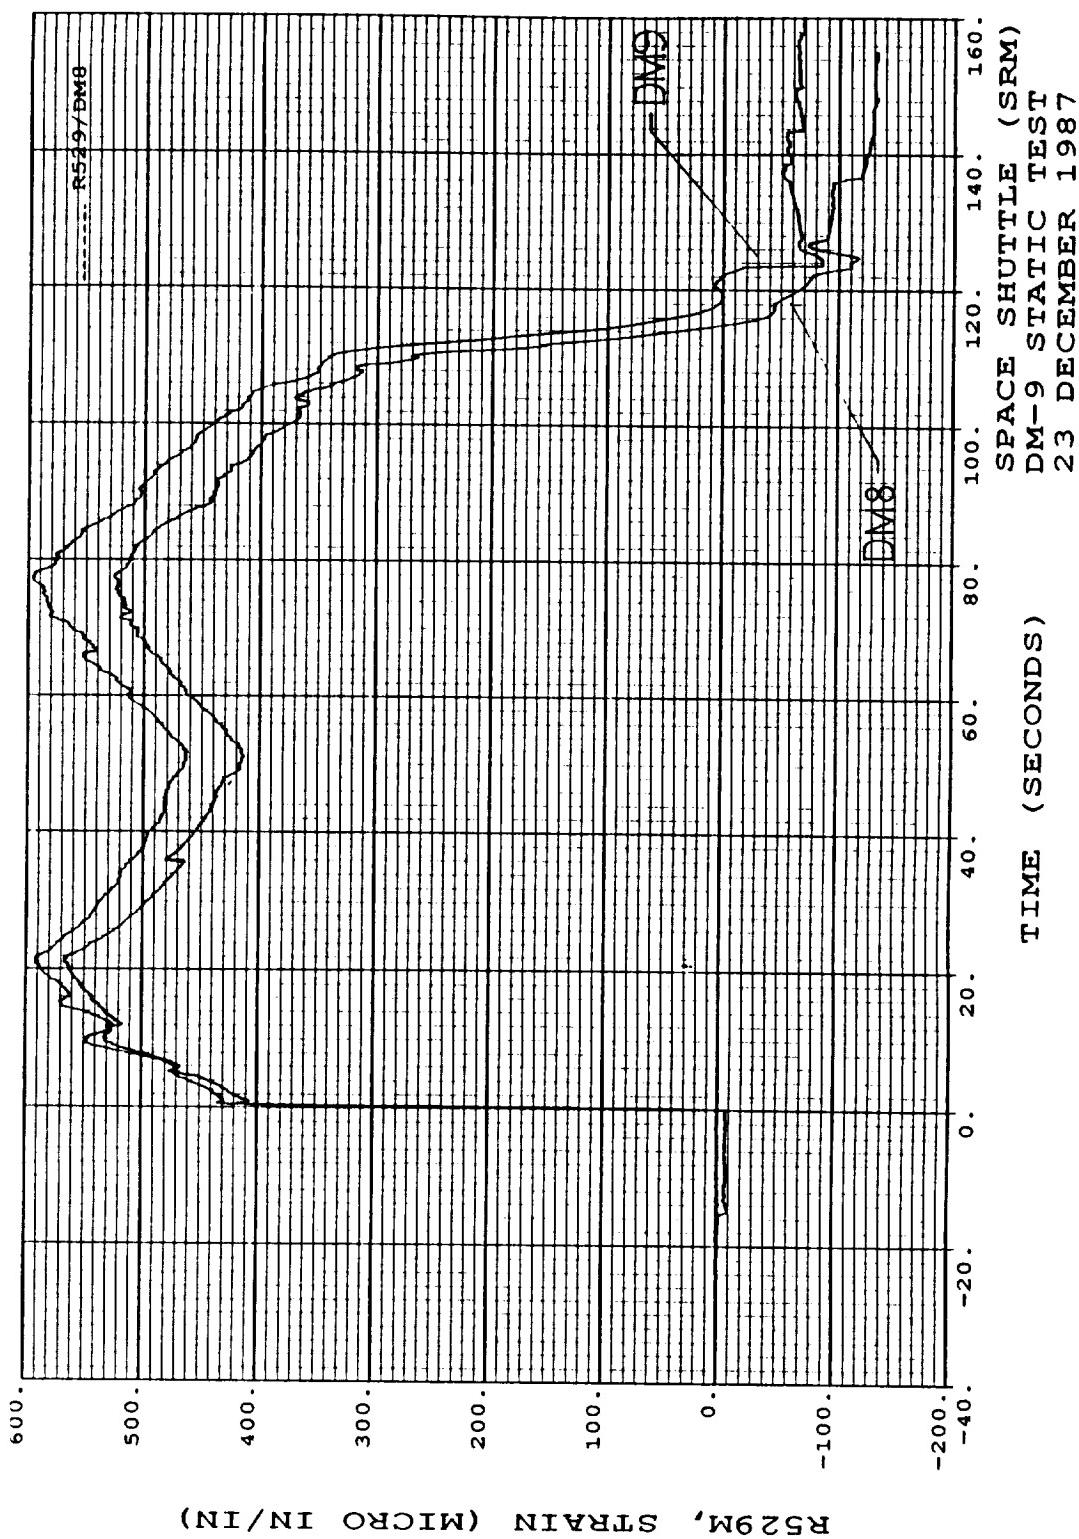
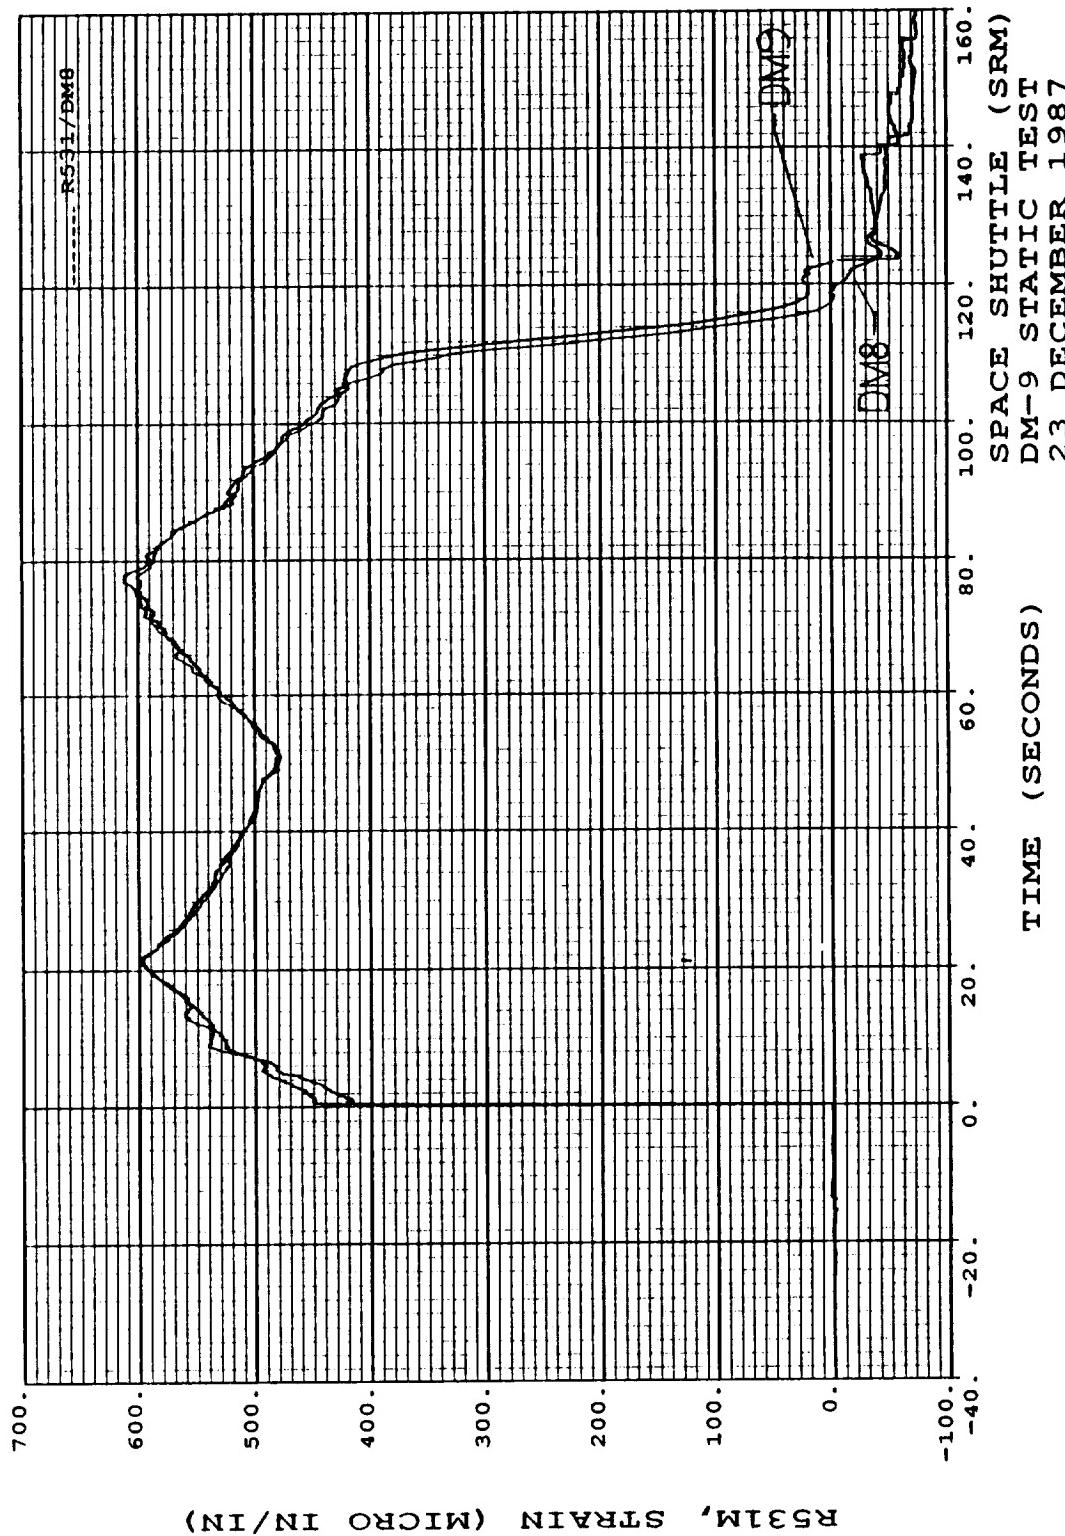
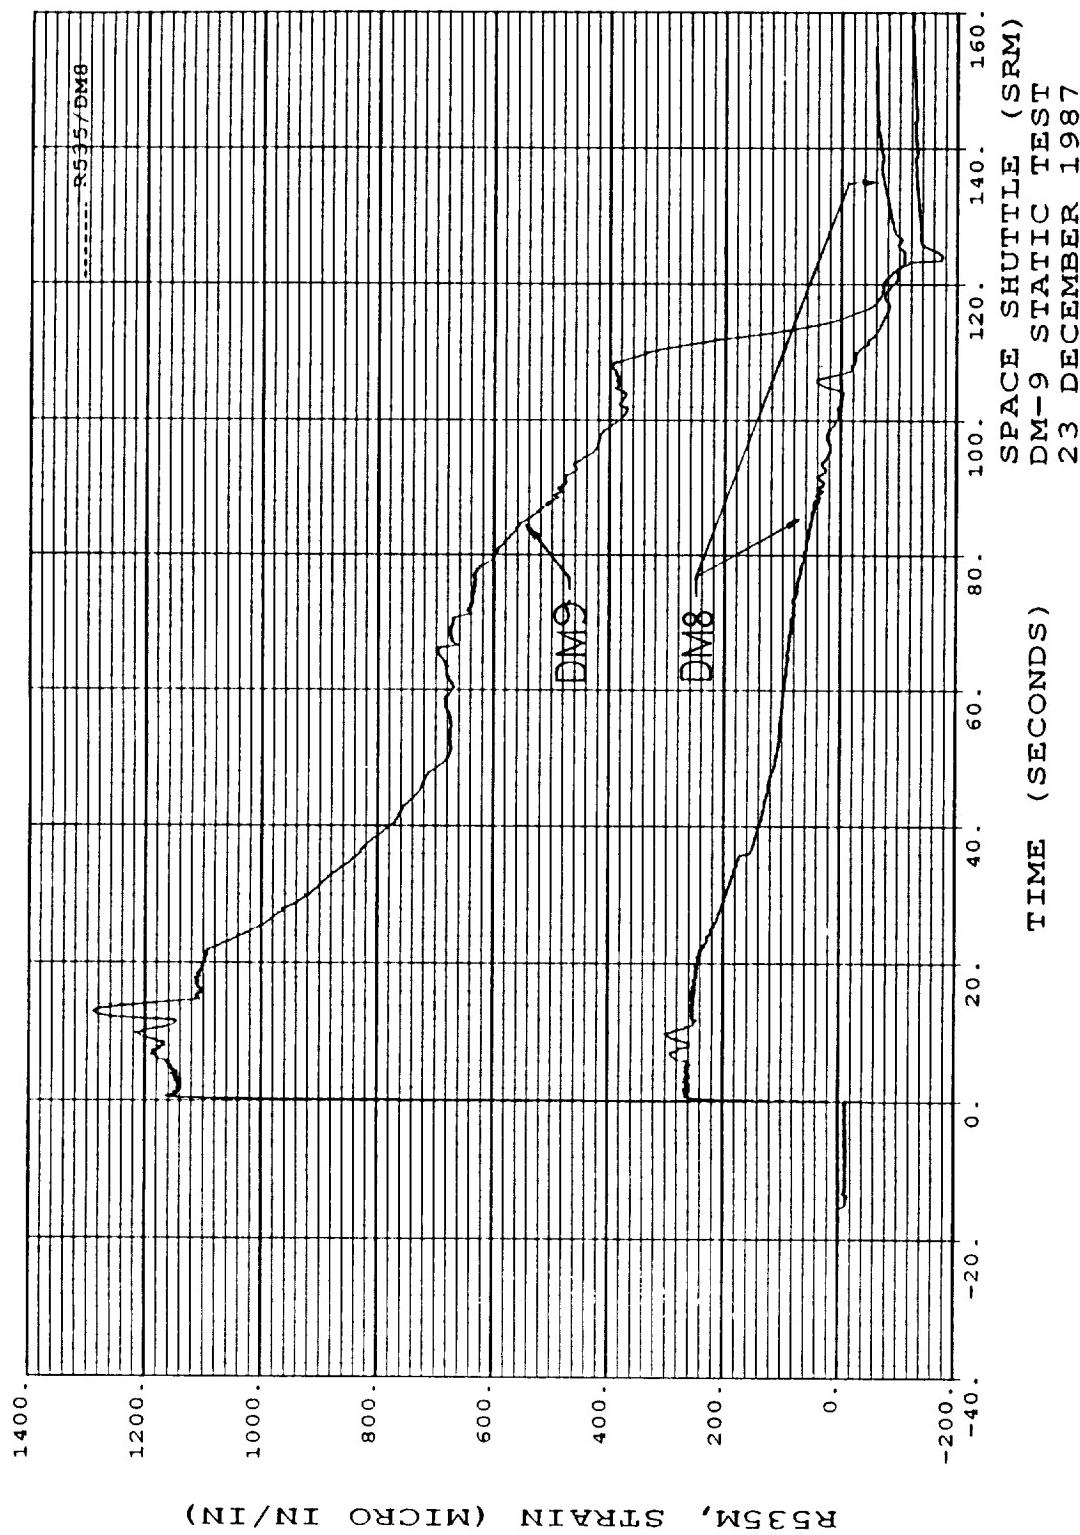
On postfire inspection of the nozzle, it was found that the involute OBR had fractured and separated from the nozzle over a 150-deg arc from 220 to 10 deg. It was eroded and delaminations were noticed in several locations. The cause and time of failure was studied and conclusions were drawn.

Figure 7.5-156. DM-9 and DM-8 Fixed Housing (meridional strains), 90 deg at Location 2

Figure 7.5-157. DM-9 and DM-8 Fixed Housing (meridional strains), 180 deg at Location 2

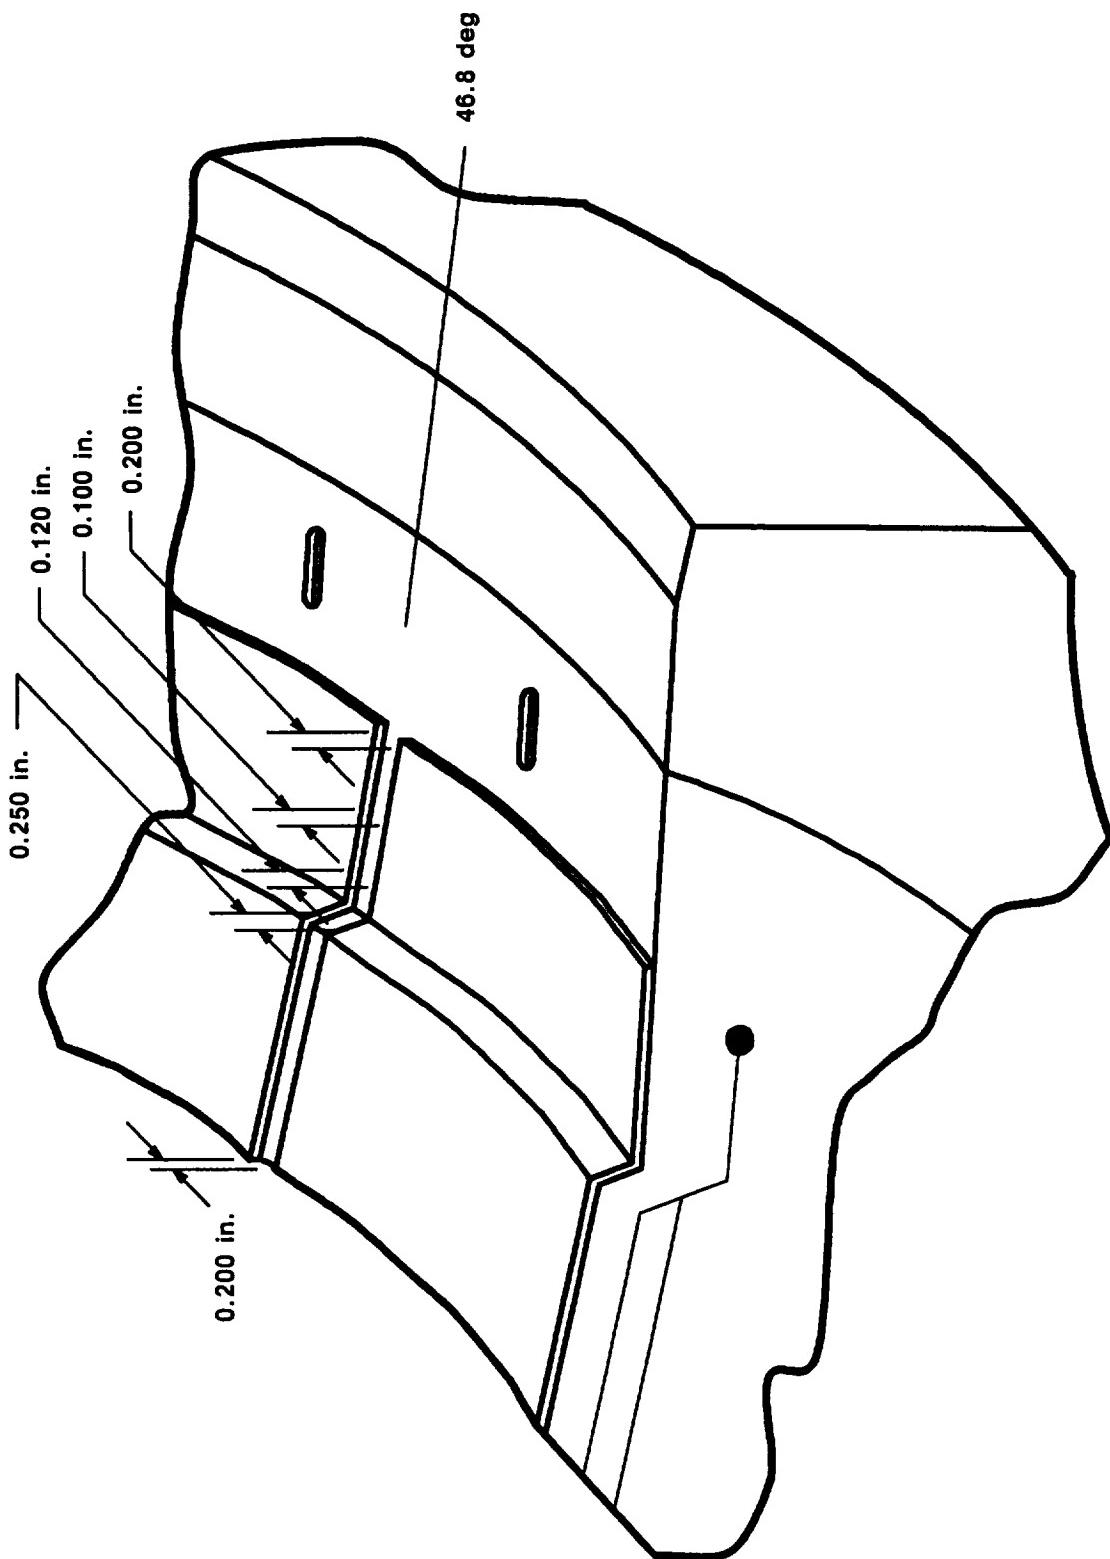
Figure 7.7-2. Nozzle-to-Case Joint Gas Path to Wiper O-ring

Twenty-one gouges were found in the wiper O-ring while it was resting in the groove during the groove inspection (Figure 7.7-4). It has been determined that these gouges were caused at disassembly by the radial bolt holes located from 131.4 to 217.8 deg. Some of the gouges were still connected to the O-ring with the open slot pointing aft. Most of the severed chips were found on the polysulfide, indicating that this happened at disassembly. Another reason to substantiate this conclusion is that radial bolt hole plugs were used during the nozzle-to-case joint assembly.

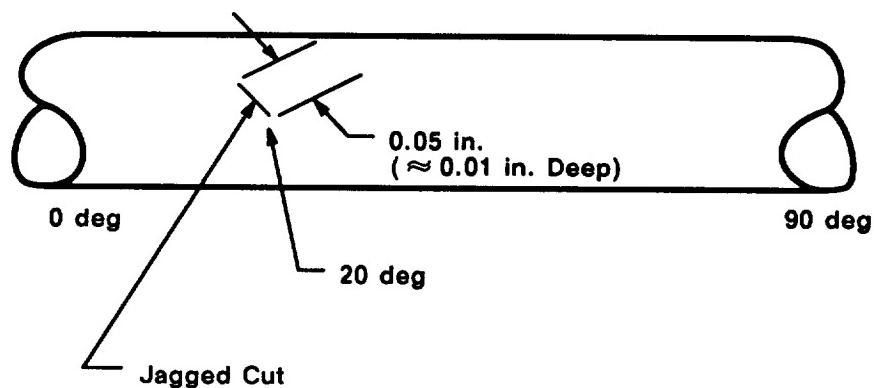
Figure 7.7-3. DM-9 Nozzle-to-Case Joint Secondary O-ring

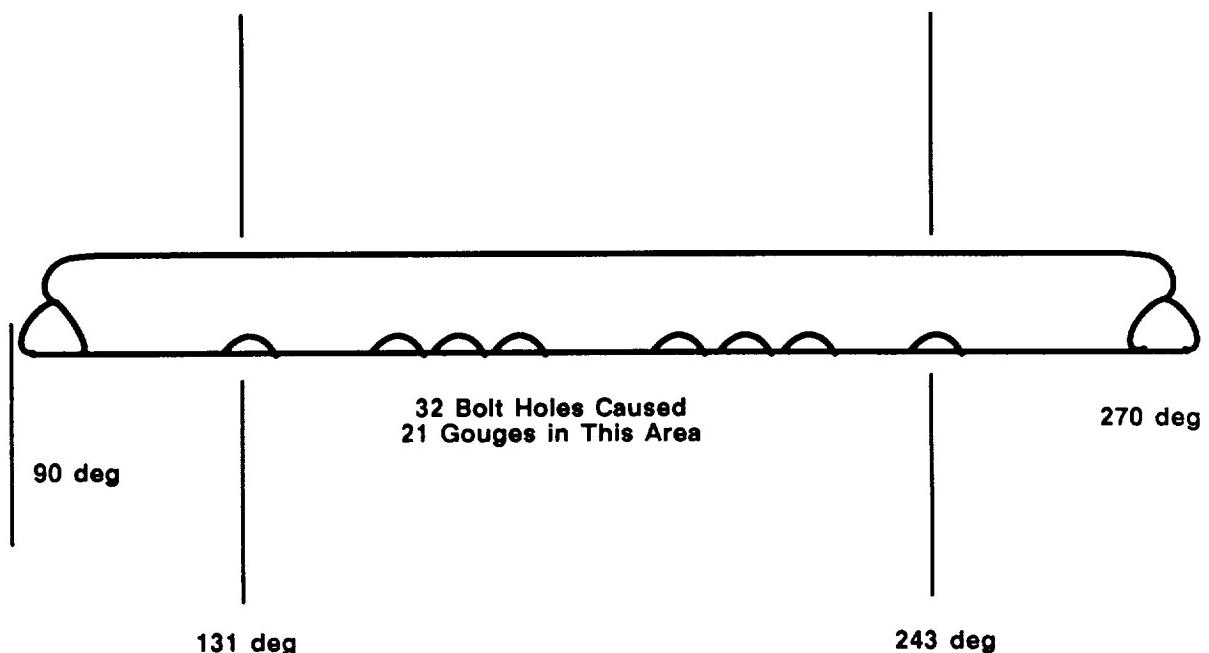
Figure 7.7-4. DM-9 Nozzle-to-Case Joint Wiper O-ring

One of the wiper O-ring chips was found in the aft side of the 149.4-deg radial bolt hole.

There was a blowhole through the polysulfide to the wiper O-ring at 46.8 deg on the nozzle-to-case joint. No blowby, erosion, or heat effects occurred to the wiper O-ring (Section 7.7.4). A jagged cut was found on the secondary O-ring of the nozzle-to-case joint at 20 deg. The cut was oriented with an angle of 45 deg and measured approximately 0.05 in. long by 0.01 in. deep. The cause of this cut is unknown, but is suspected to be handling damage. This was concluded from the nature of the cut on the face seal secondary O-ring. Joint contamination (lint and hair) was found on all three field joints. Four of the five internal\

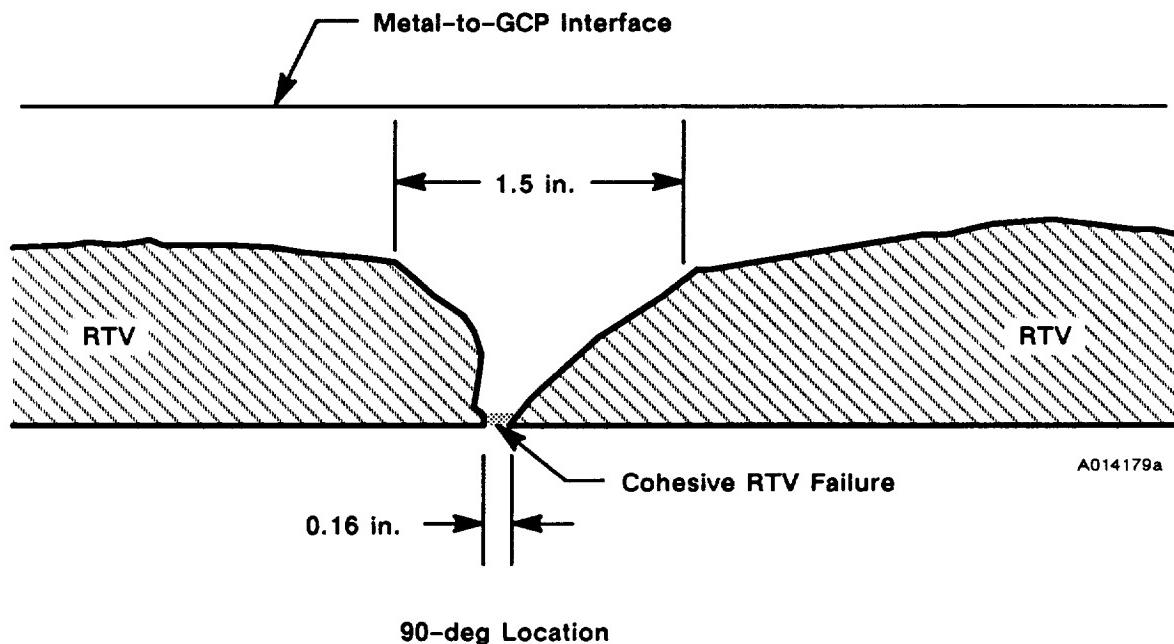
Figure 7.7-5. Void in RTV at Nose Inlet-to-Throat Support Housing Joint

A triangular void area in the RTV was found at 90 deg which allowed pressure to reach the primary O-ring at some time during the static test (Figure 7.7-5). The void area was not exposed to pressure until the char line degraded the strength of the RTV at the opening of the void. This decrease in strength allowed pressure to produce a cohesive failure in the RTV at the opening of the void. The base of the void was 1.0 in. wide, whereas the opening of the void was 0.16 in. wide. Excessive grease was found between the primary and secondary seals; also, a grease bead was

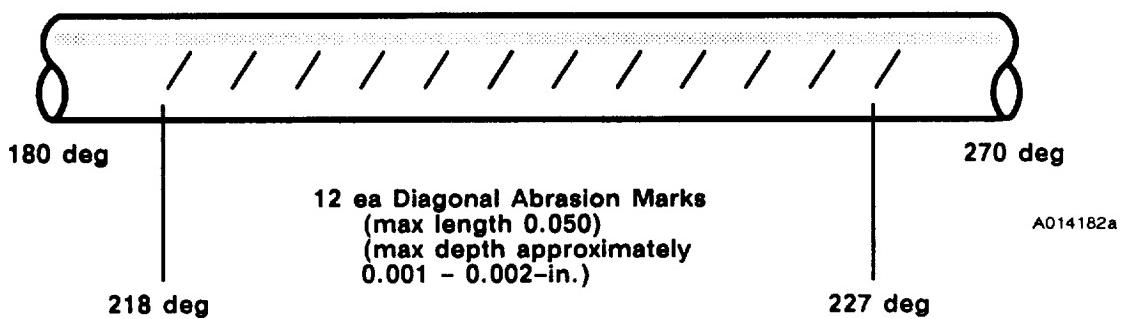
diagonal abrasion marks (12 each) with a maximum length of 0.050 in. and maximum depth of 0.001 to 0.002 inches (Figure 7.7-8). These were found at 218 through 227 deg. It was determined that they were caused by disassembly.

Figure 7.7-8. DM-9 Fixed Housing-to-Aft End Ring, O-ring

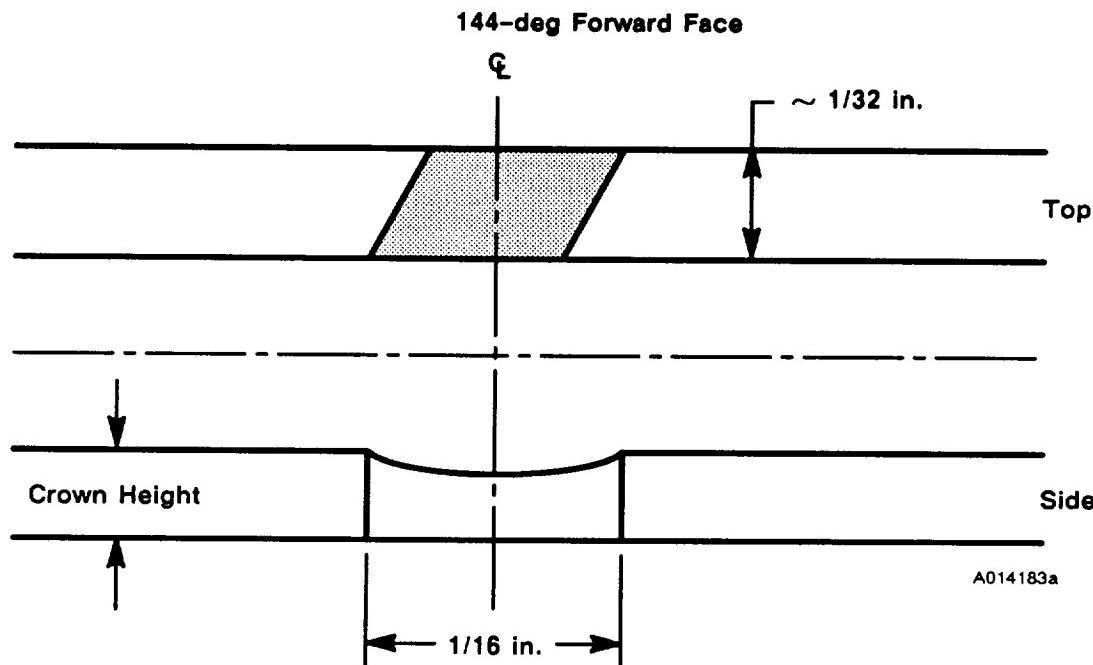
A blowhole of approximately 3 in. long and 0.5 in. wide was found in the putty of the igniter case exterior at the 335-deg location. There was no soot on the forward face of the outer seal, but during a thorough visual inspection a depression was found on the crown of the primary seal at the 144-deg location (Figure 7.7-9). It was concluded that this depression was due to a manufacturing defect. Laboratory analysis (Thiokol analysis) showed that there was residue of nitrile rubber particles embedded in the depression area. It is suspected that the nitrile material entered the fluorocarbon material at the time of mixing.

Figure 7.7-9. DM-9 Igniter Outer Gasket Primary Seal Crown

Major Anomalies: The depression found on the crown of the primary seal at 144 deg of the igniter gasket.

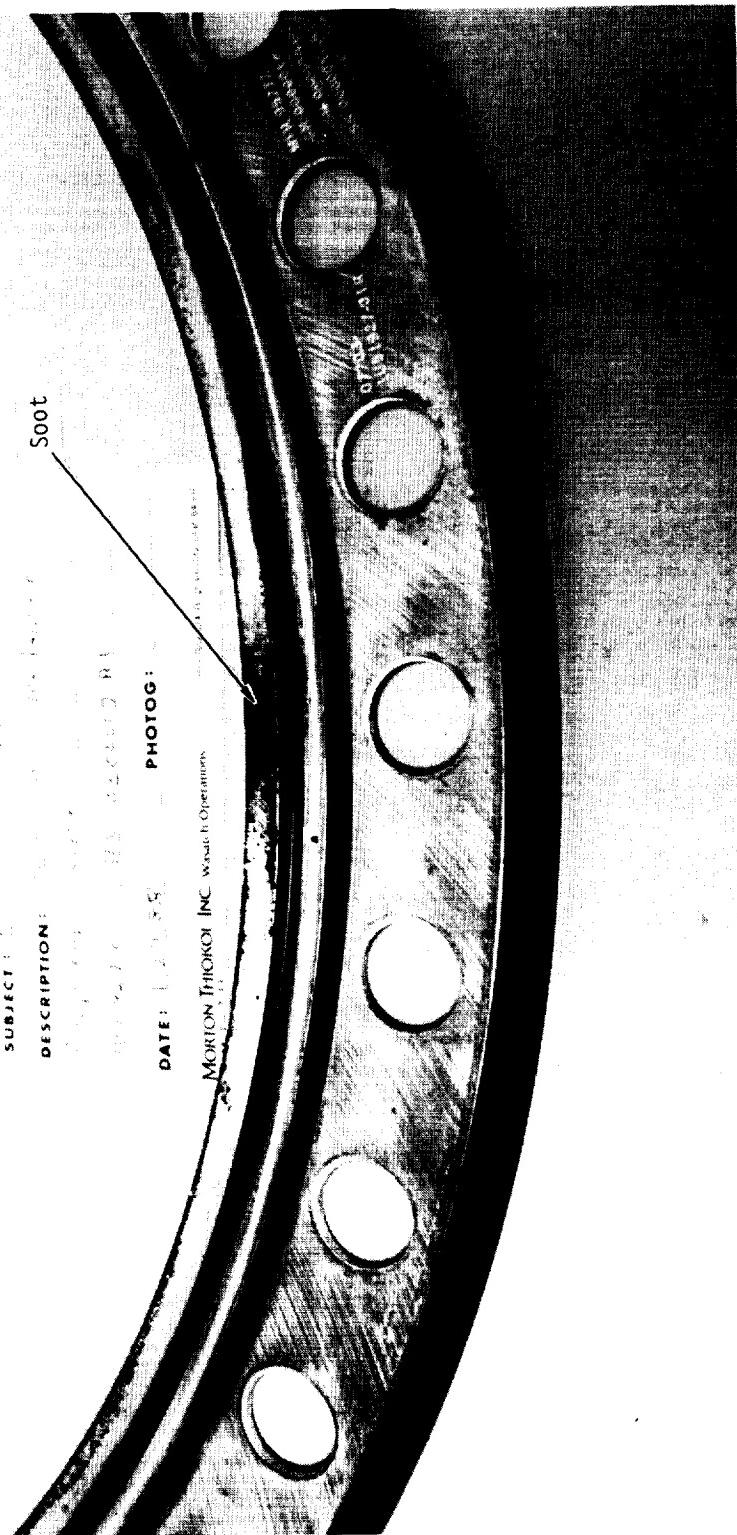
Figure 7.8-7. DM-9 Igniter Outer Gasket

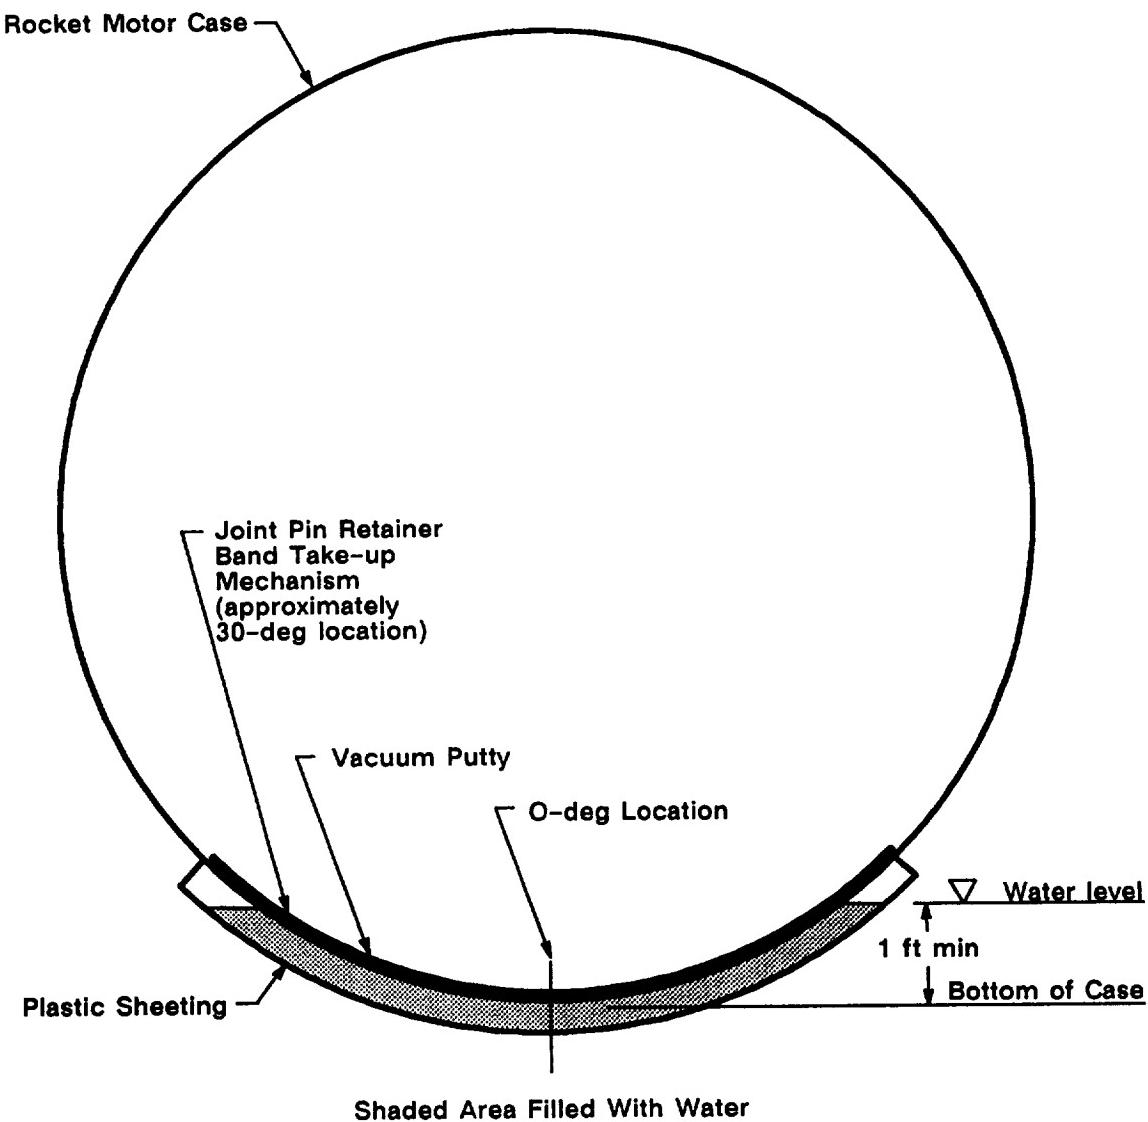
- b. Weatherseal. Following the static firing of DM-9, a 2 by 12 ft plastic sheeting was installed over the lower portion of the forward field joint and forward segment factory joint (Figure 7.9-6). The sheeting extended circumferentially around the case far enough to allow for 1-ft head of water from the bottom of the motor and centered over the joint. Water was allowed to stand for 73 hr for the field joint and 72 hr for the factory joint. During moisture testing the joint temperature was between 60° and 70°F. No water was found within the factory joint moisture seal. Water seeped into the field joint moisture seal at the joint pin retainer band takeup mechanism. This mechanism caused the moisture seal to be locally lifted off the case. A low-profile pin retainer band takeup mechanism has been designed, and a rain test will be conducted in a vertical position to qualify the field joint moisture seal.

Figure 7.9-6. Moisture Seal Test Setup
